Assessing earthquake effects on archaeological sites: the employment of photogrammetry and 3D model analysis

Paolo Forlin, Riccardo Valente, Miklós Kázmér

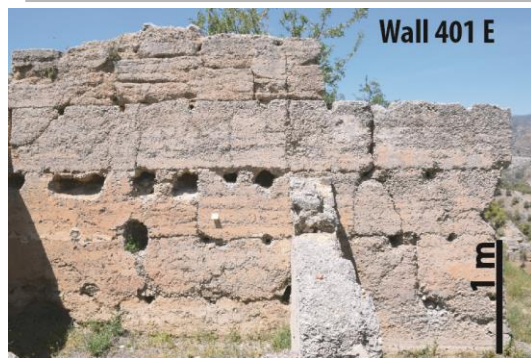
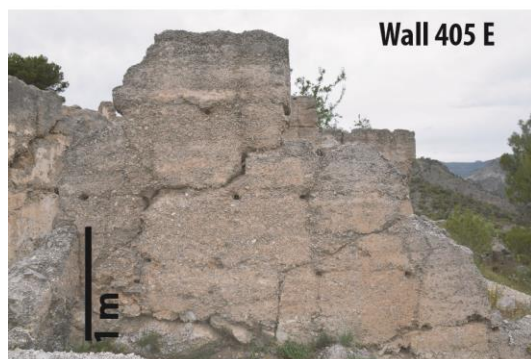
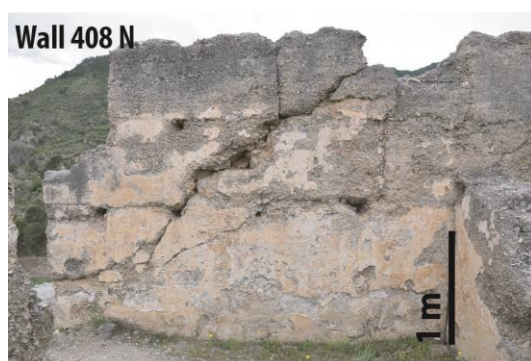
Seismic damage consists of a variety of penetrative fractures such as horizontal, vertical and shear cracks with some evidence of the shifting of rammed earth blocks (**fig. 3**).

Fig. 3. El Castillejo. Seismic damage visible on the standing structures of Building 4.

Wall 408, the southern wall of Building 4, contains a huge penetrative, shear crack crossing the entire height of the structure. It can be observed as an individual feature on the external wall (408-south), but it is associated with minor (shear and vertical) cracks on the internal wall face (408-north). The western wall of the building (405) shows other, huge shear cracks associated –as in the case with 408- with vertical, sub-vertical and sub-horizontal fractures. Wall 401, the structure's western wall, preserves evidence of seismic damage represented by a composite network of vertical, sub-vertical and horizontal fractures. The upper *tapial* block is displaced and rotated, a point which can be clearly observed from the external profile of the wall. As already mentioned, at some point the building's northern wall (404) entirely collapsed, and no EAEs are recognisable on the *in situ* foundations.

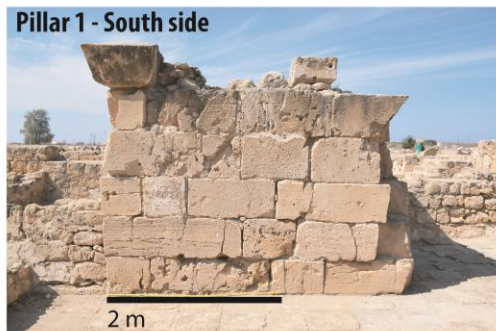
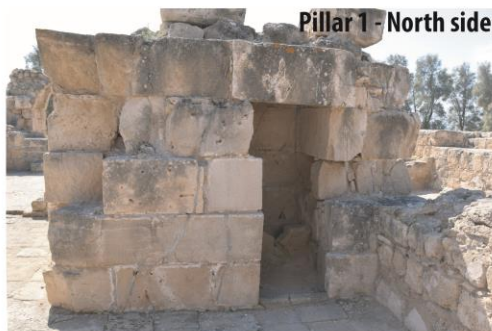
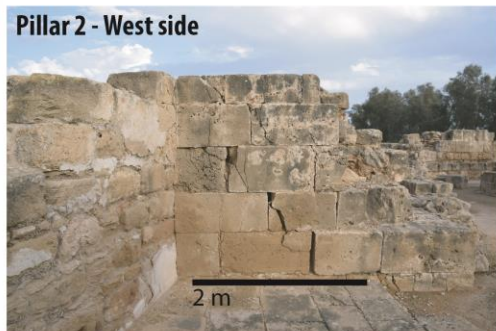
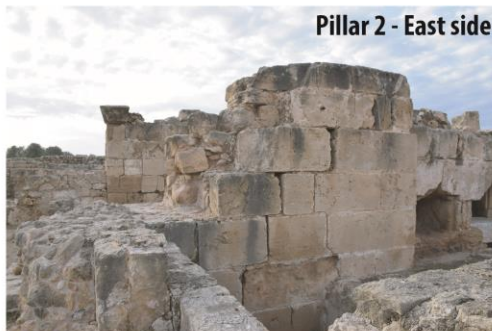
Pillar 1 (**Fig. 5**) is a massive quadrangular structure (measuring 3.68m x 3.67m) hosting two opposing latrines on the north and south sides. Pillar 2 (**Fig. 5**) is a rectangular pillar measuring 3.47m x 2.15m connected to the castle's kitchen along its northern face. Both structures are only partially preserved, their upper parts having collapsed as a result of the AD 1222 earthquake. The remains of pillar 1 reach a maximum height of 3.29m, while pillar 2 is only preserved up to 2.35m. One corner of pillar 1 appears to have been heavily restored by means of cobble stones.

Despite the state of preservation of the pillars, EAEs are clearly visible throughout the structures. Pillar 1 is widely affected by sub-vertical cracks running across several courses of ashlar and masonry blocks. The latrines were also seismically-affected, with both the internal walls and toilet seats fractured by vertical cracks. The structure, as a whole, is deformed by vertical compression and, as a result of the vertical seismic loads, the structure's faces are extruded in profile. Pillar 2 is poorly preserved, with only five courses of the structure remaining *in situ*. The pillar's western and eastern faces show a collapse interface corresponding with a distinctive shear feature, with the surviving elements containing a shear fracture cross-cutting multiple courses of ashlar. This penetrative fracture is associated with a right-lateral displacement.

Fig. 5. Saranda Kolones. Pillar 1 and Pillar 2 showing distinctive seismic damage.

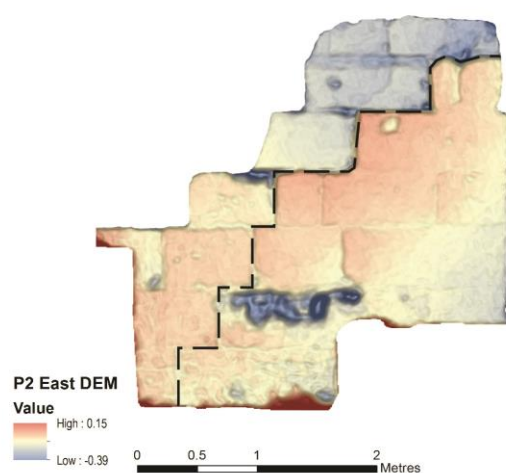
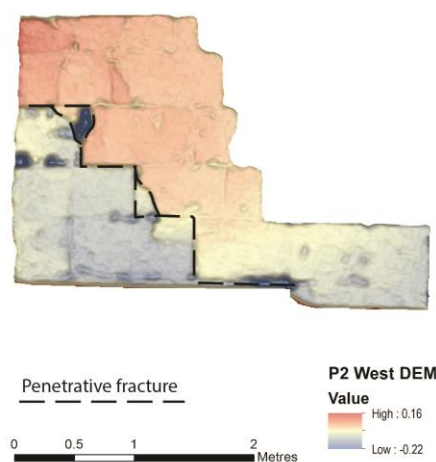
Saranda Kolones - Pilaster 2

The 3D meshes produced through photogrammetry of pillar 1 and 2 also facilitate an in-depth archaeoseismological analysis. Again, seismic damage such as shear and sub-horizontal cracks are clearly discernible within the 3D model. **Figure 15**, for instance, compares a close-up picture of a shear crack associated with lateral shifting in pillar 2 with the resulting 3D model. A series of parallel horizontal sections drawn, at different heights, through pillar 1 and 2 allow observation of the degree of cracking and displacement which have affected the structure. Sections A and B from pillar 2 (**fig. 16**) show centimetre-scale displacement of masonry blocks on both sides of the structure at 0.25 m (A) and 1.10 m (B) above floor level. The displacement extracted from the 3D model (1.5 to 3.3 cm) corresponds with the misalignment measured in the field. The extracted DEM visualises the same displacement, enhancing the out-of-plane shifting of the upper part of the pillar’s surviving structure. Fig. 17 shows the intrusion of the upper blocks on the eastern side and, on the other hand, the extrusion of the upper portion on its western side. This deformation augments upward and is clearly associated with the shear, penetrative fracture detectable on the structure.

Fig. 15. Saranda Kolones, pillar 2, western side. Comparison between a close-up of a shear crack associated with lateral shifting (A) with the resulting 3D model (B).

This evidence is highly significant, as deformation cutting across a pillar and the uniformity of deformation in adjacent pillars (the same effect was identified on Pillar 1) are a certain indication of earthquake action. A displacement as minor as 1-4 cm
